AMD-K6[®]-2

Processor Revision Guide

Model 8

Publication # 21641 Rev: F Amendment/ 0 Issue Date: June 1999
--

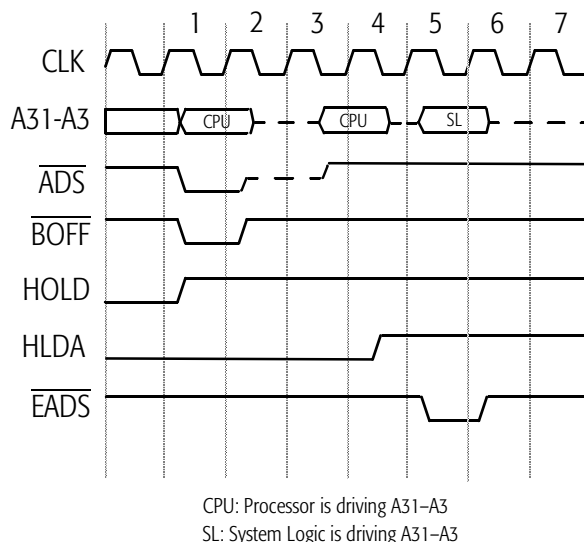
Figure 1. AMD-K6[®]-2 Processor Assertion of HLDA Due to Simultaneous \overline{BOFF} /HOLD Assertion

Non-conformance. If $\overline{\text{BOFF}}$ and HOLD are sampled asserted on the same clock edge that negates $\overline{\text{ADS}}$, the processor asserts HLDA two clock edges after HOLD is sampled asserted.

- If the system logic asserts $\overline{\text{BOFF}}$ for a duration of one clock, anticipates the assertion of HLDA in clock 3 (see Figure 1)—which is the normal specified operation—and drives the address bus and $\overline{\text{EADS}}$ for an inquire cycle in clock 3, then the processor will not sample $\overline{\text{EADS}}$ asserted. In addition, address bus contention will occur in clock 3.

If the processor does not sample $\overline{\text{EADS}}$ asserted during an inquire cycle, cache/memory incoherency will occur. Address bus contention can affect the reliability of the processor and the system logic.

Suggested Workaround. The system logic must sample the assertion of HLDA before asserting $\overline{\text{EADS}}$ and driving the address bus for an inquire cycle—as shown in clock 5 of Figure 1.
