# **AMD-K6<sup>®</sup>**

## **Processor Revision Guide**

### **Model 7**

Publication # <b>21846</b> Rev: <b>H</b> Amendment/ <b>0</b> Issue Date: <b>June 1999</b>
--

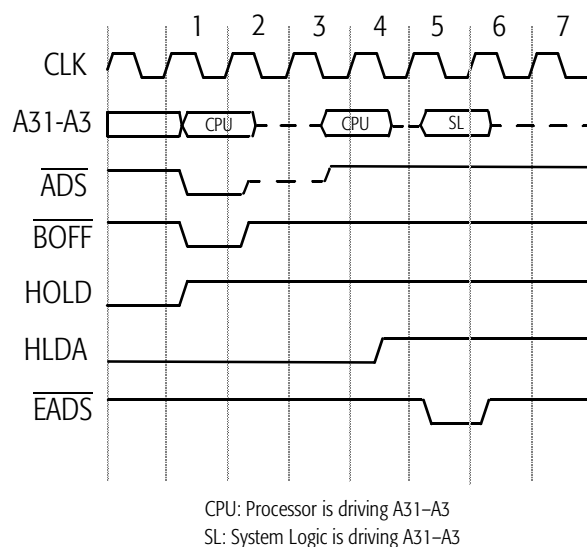
**Figure 1. AMD-K6<sup>®</sup> Processor Assertion of HLDA Due to Simultaneous  $\overline{\text{BOFF}}$ /HOLD Assertion**

**Non-conformance.** If  $\overline{\text{BOFF}}$  and HOLD are sampled asserted on the same clock edge that negates  $\overline{\text{ADS}}$ , the processor asserts HLDA two clock edges after HOLD is sampled asserted.

- If the system logic asserts  $\overline{\text{BOFF}}$  for a duration of one clock, anticipates the assertion of HLDA in clock 3 (see Figure 1)—which is the normal specified operation—and drives the address bus and  $\overline{\text{EADS}}$  for an inquire cycle in clock 3, then the processor will not sample  $\overline{\text{EADS}}$  asserted. In addition, address bus contention will occur in clock 3.

- If the system logic asserts  $\overline{\text{BOFF}}$  for a duration of two clocks, anticipates the assertion of HLDA in clock 3, and drives the address bus and  $\overline{\text{EADS}}$  for an inquire cycle in clock 3, then the processor will not sample  $\overline{\text{EADS}}$  asserted. (No address bus contention occurs in this case.)

- If the system logic asserts  $\overline{\text{BOFF}}$  for a duration of one clock, anticipates the assertion of HLDA in clock 3, and drives the address bus and  $\overline{\text{EADS}}$  for an inquire cycle in clock 4, then address bus contention may occur in clock 4. (The processor will sample  $\overline{\text{EADS}}$  asserted in this case.)

If the processor does not sample  $\overline{\text{EADS}}$  asserted during an inquire cycle, cache/memory incoherency will occur. Address bus contention can affect the reliability of the processor and the system logic.

**Suggested Workaround.** The system logic must sample the assertion of HLDA before asserting  $\overline{\text{EADS}}$  and driving the address bus for an inquire cycle—as shown in clock 5 of Figure 1.
