Intel® Atom™ Processor 200^Δ Series

Specification Update

April 2010

Revision 004

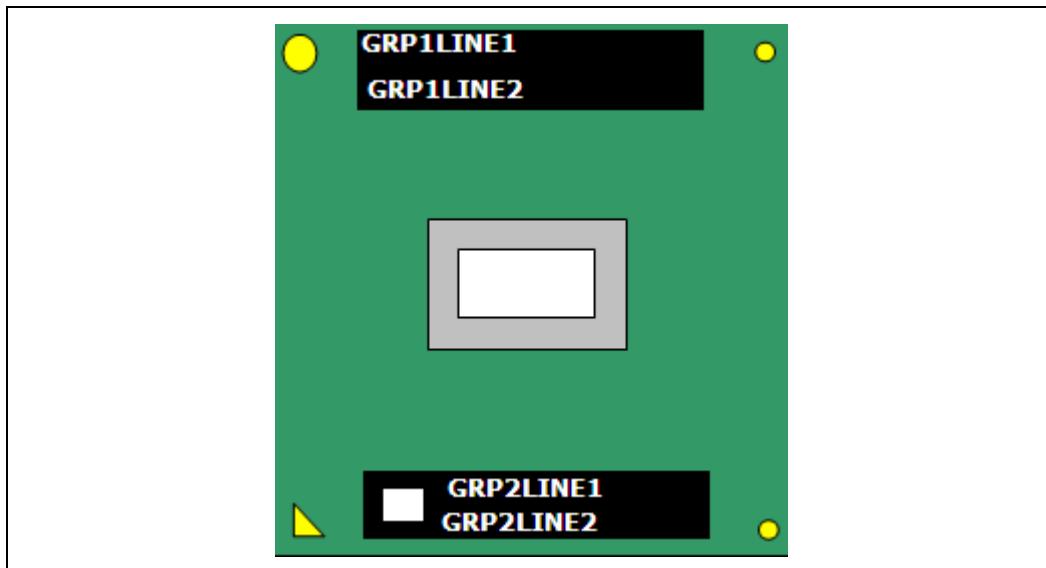
Figure 1. Intel® Atom™ Processor 200 Series (Micro-FCPGA/FCBGA) Markings

The Intel® Atom™ Processor 200 Series may be identified by the following component markings.
