# **Intel® Atom™ Processor 300<sup>Δ</sup> Series**

**Specification Update**

*Revision 004*

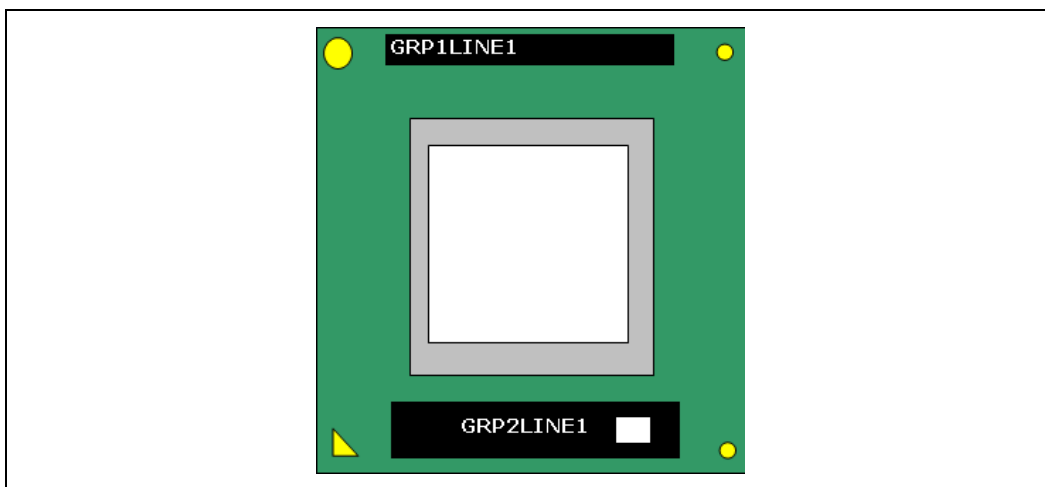
**Figure 1. Intel® Atom™ Processor 300 Series (Micro-FCPGA/FCBGA) Markings**

The Intel® Atom™ Processor 300 Series processor may be identified by the following component markings.
