# Intel® Atom™ Processor N270 Series

Specification Update

*September 2008*

*Revision 003*

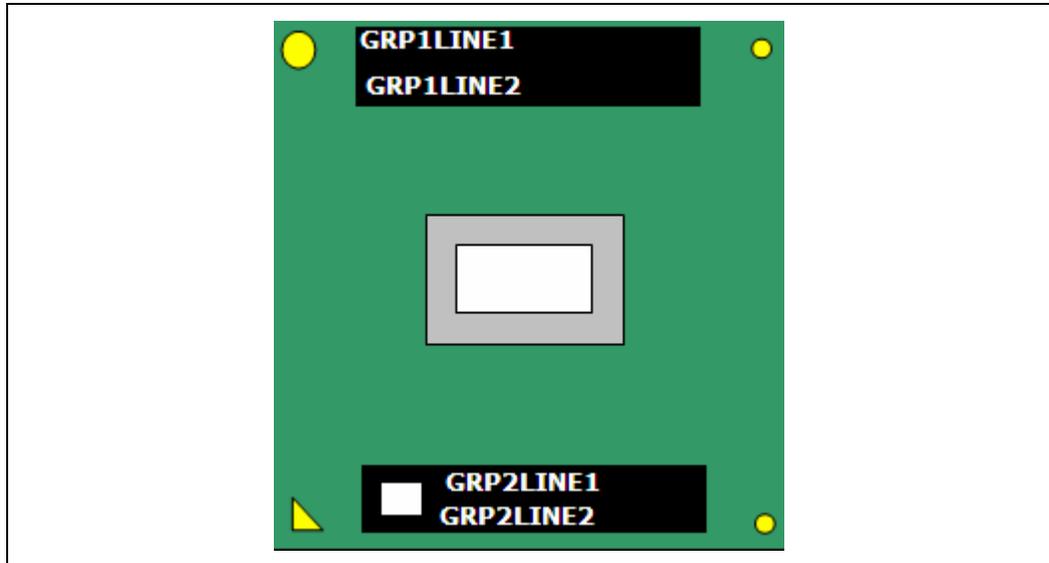
Figure 1. Mobile Intel® Atom™ Processor N270 Series (FCBGA8) Markings

Mobile Intel® Atom™ processor N270 series is identified by the following component markings.
